PROJECT NO.: SM 302519-E

FEBRUARY 3, 2022

**PHASE ONE ENVIRONMENTAL SITE ASSESSMENT
1284 MAIN STREET EAST
HAMILTON, ONTARIO**

**SOIL-MAT ENGINEERS & CONSULTANTS LTD.
130 LANCING DRIVE
HAMILTON, ONTARIO
L8W 3A1**

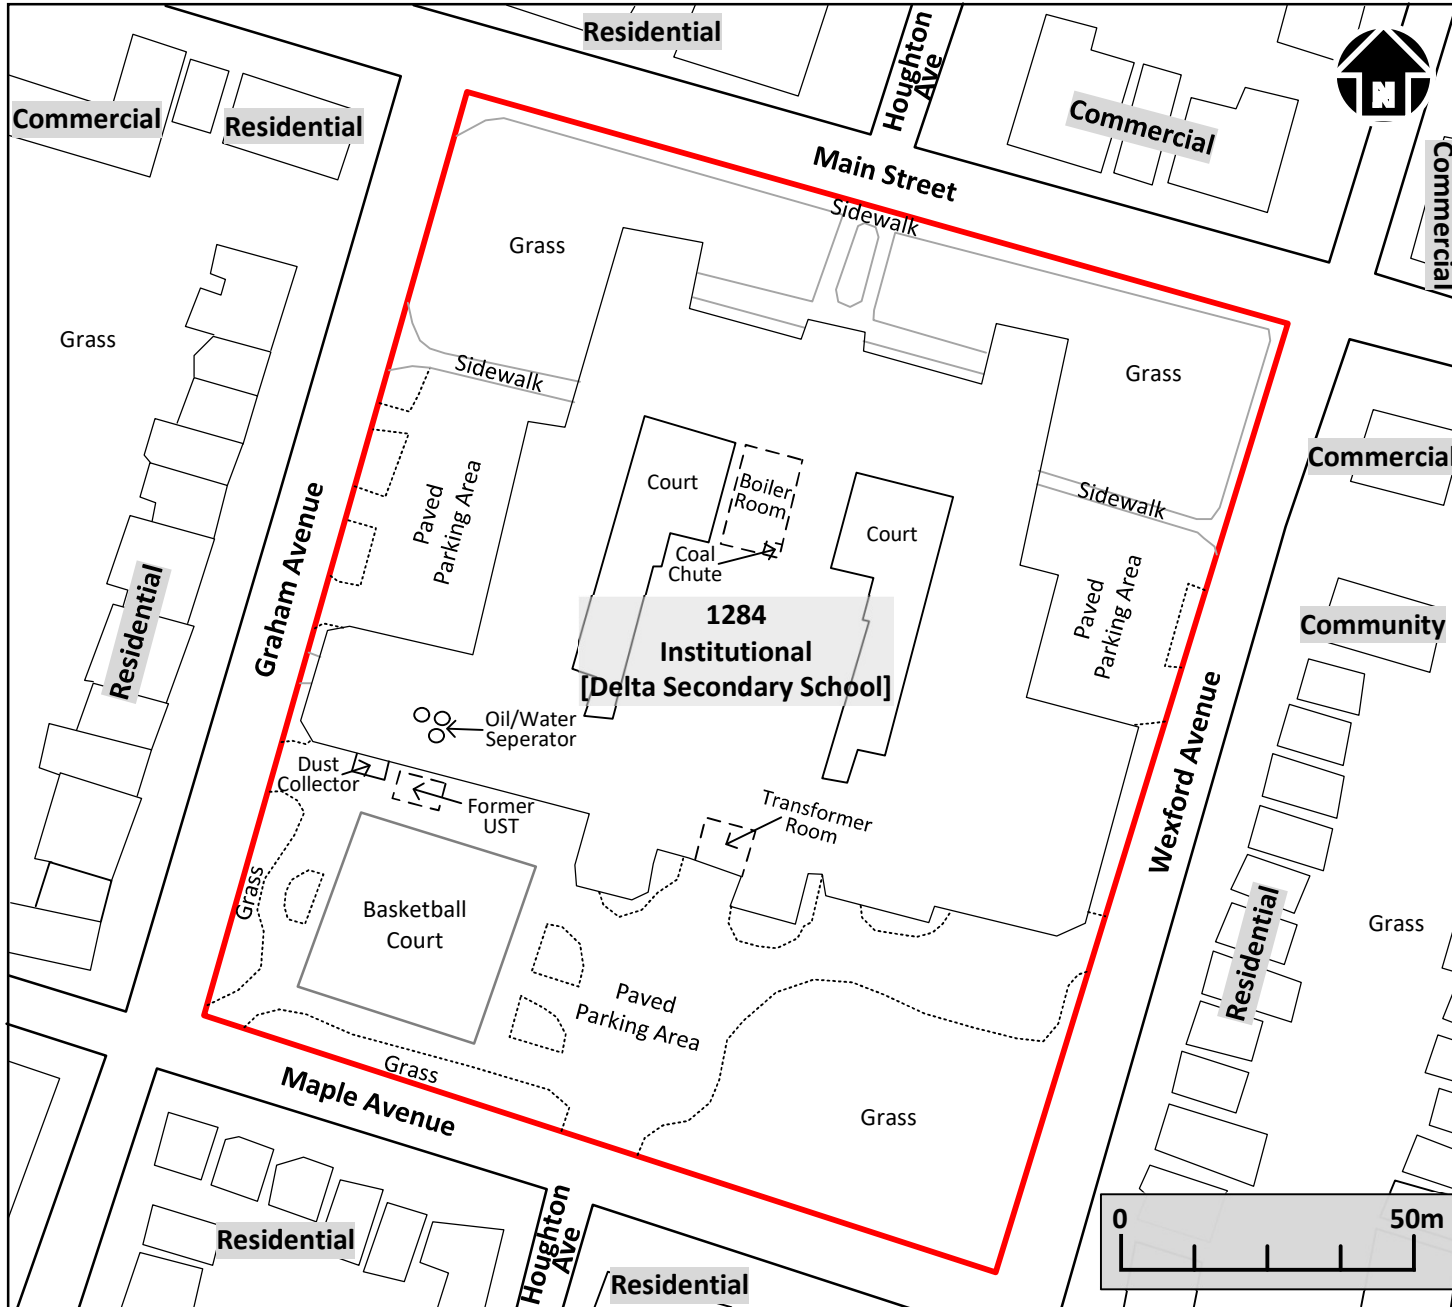
DRAWING No. 1

At the time of this Report, the Phase One Property was comprised of an roughly rectangular shaped parcel of land that was occupied by a three [3] storey institutional building identified as Delta Secondary School. The remainder of the Phase One Property was comprised of asphaltic-concrete covered parking lots on the eastern and western portions of the Phase One Property. In addition, an asphaltic-concrete playground and basketball court was located on the southern portion of the Phase One Property. With the exception of sidewalks leading to the main doors on the northern portion of the school building, the remaindered of the Phase One Property was comprised of grass covered areas.

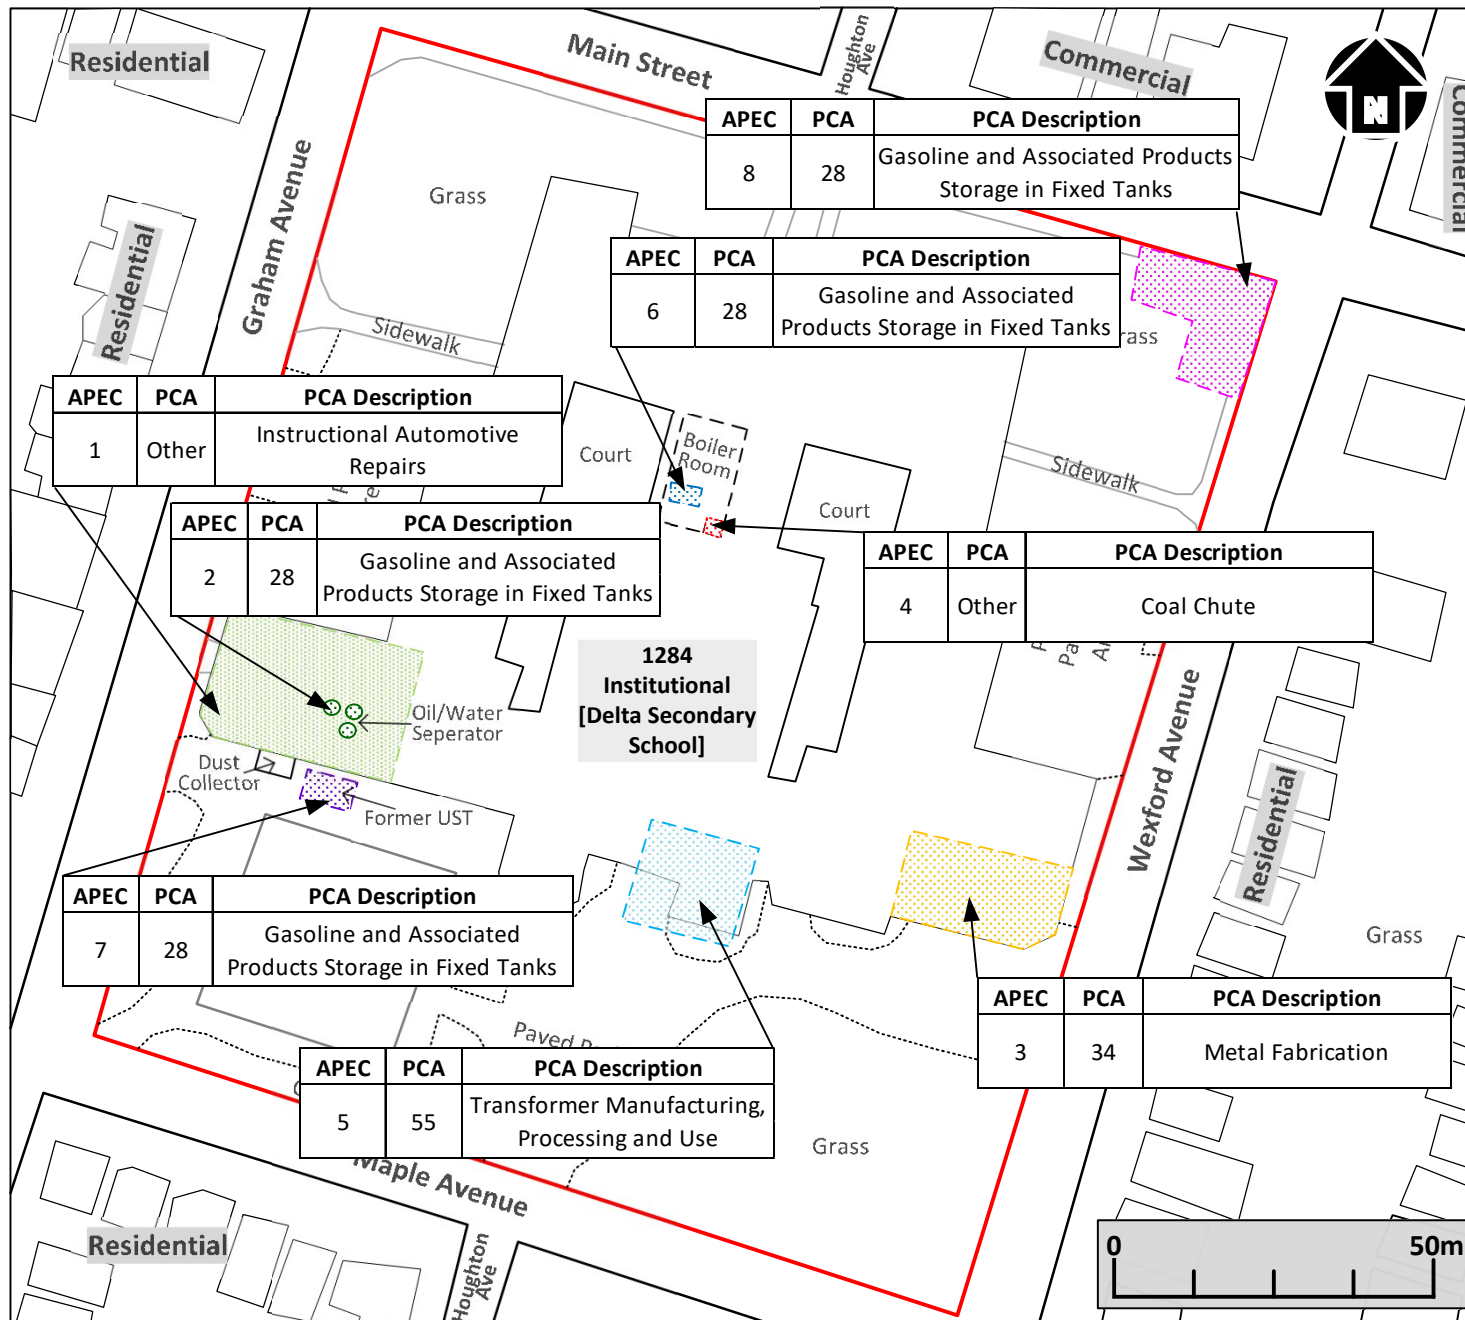
DRAWING No. 1A

The research undertaken during this Phase One ESA revealed information that suggests there are seven [7] PCAs on the Phase One Property and one PCA on a property within the Phase One Study Area that are considered likely to cause an APEC on the Site.

- = Site Boundary
- = APEC 1
- = APEC 2
- = APEC 3
- = APEC 4
- = APEC 5
- = APEC 6
- = APEC 7
- = APEC 8

Environmental Liability	Recommendation	Rationale
1. PCA No. Other: Instructional Automotive Repairs	<p>Advance a series of boreholes and install a groundwater monitoring in the area associated with the instructional automotive shop.</p> <p>The contaminants of potential concern [COPCs] should include Metals and Inorganics, Volatile Organic Compounds [VOCs], Petroleum Hydrocarbons [PHCs], polycyclic aromatic hydrocarbons [PAHs] and Benzene, Toluene, Ethylbenzene, and Xylenes [BTEX].</p>	Assess the potential adverse impacts to the soil and groundwater mediums in connection with the on-Site instructional automotive shop.

Environmental Liability	Recommendation	Rationale
2. PCA No.28: Gasoline and Associated Products Storage in Fixed Tanks	Advance a series of boreholes, and install a groundwater monitoring well, in the immediate vicinity of the existing waste oil/water separator. The COPC should include Metals and Inorganics, VOCs, PAHs, PHCs, and BTEX.	Assess the potential adverse impacts to the soil and groundwater mediums in connection with the existing oil/water separator.

6. PCA No.28: Gasoline and Associated Products Storage in Fixed Tanks	Advance a borehole adjacent the large compressor observed in the basement level of the school building. The COPC should include PHCs, and BTEX.	Assess the potential adverse impacts to the soil medium in connection with the observed staining around the on-Site compressor.

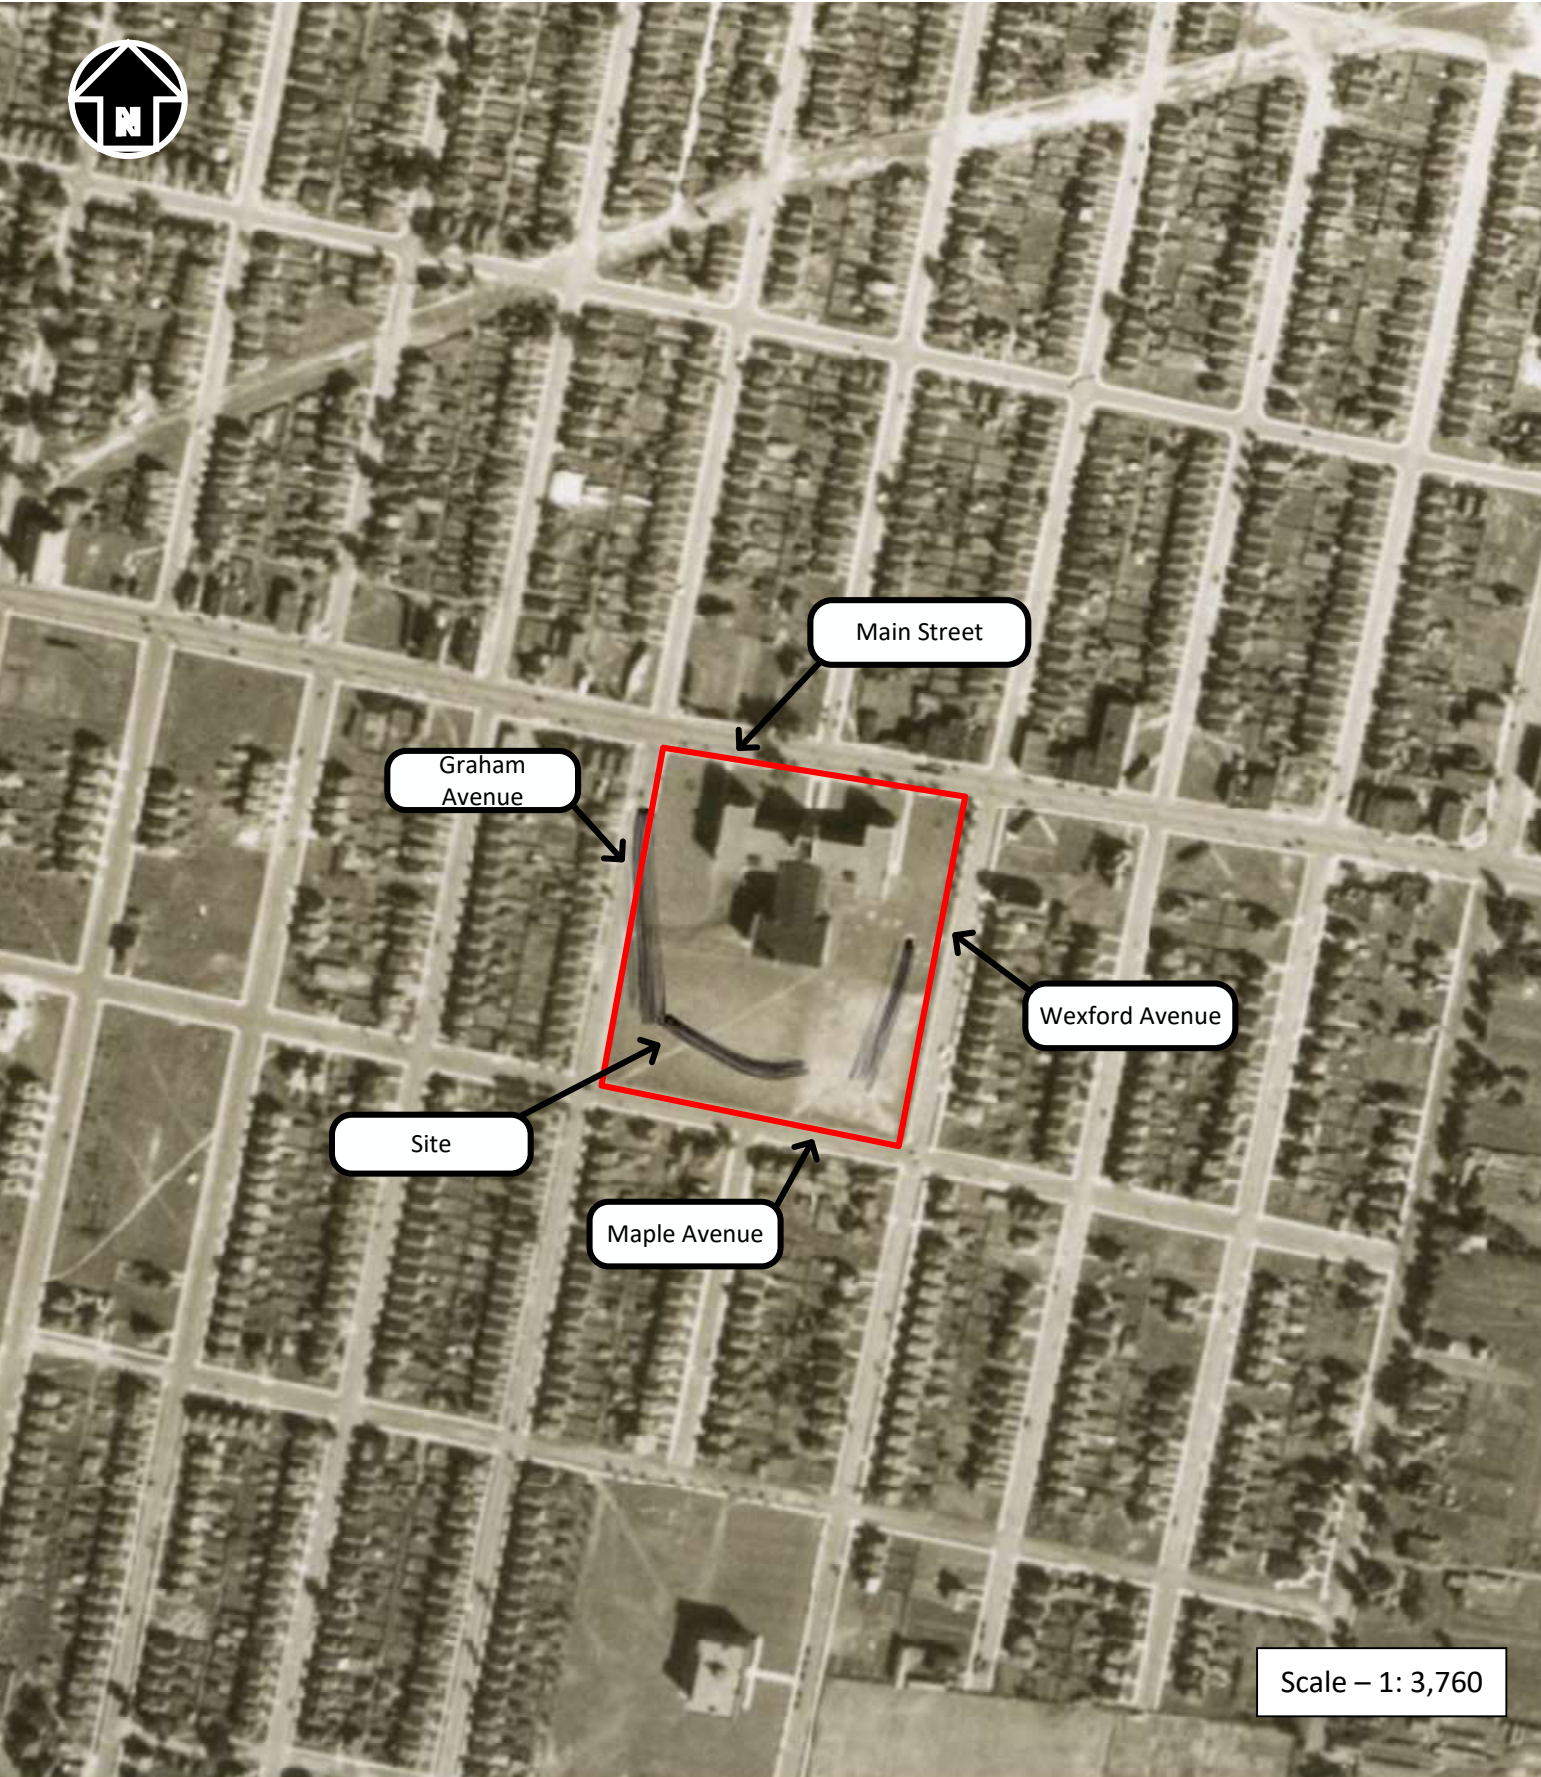
Aerial Photo – 1934

The review of the available aerial photographs did not reveal any PCAs that are likely to cause an APEC on the Site.

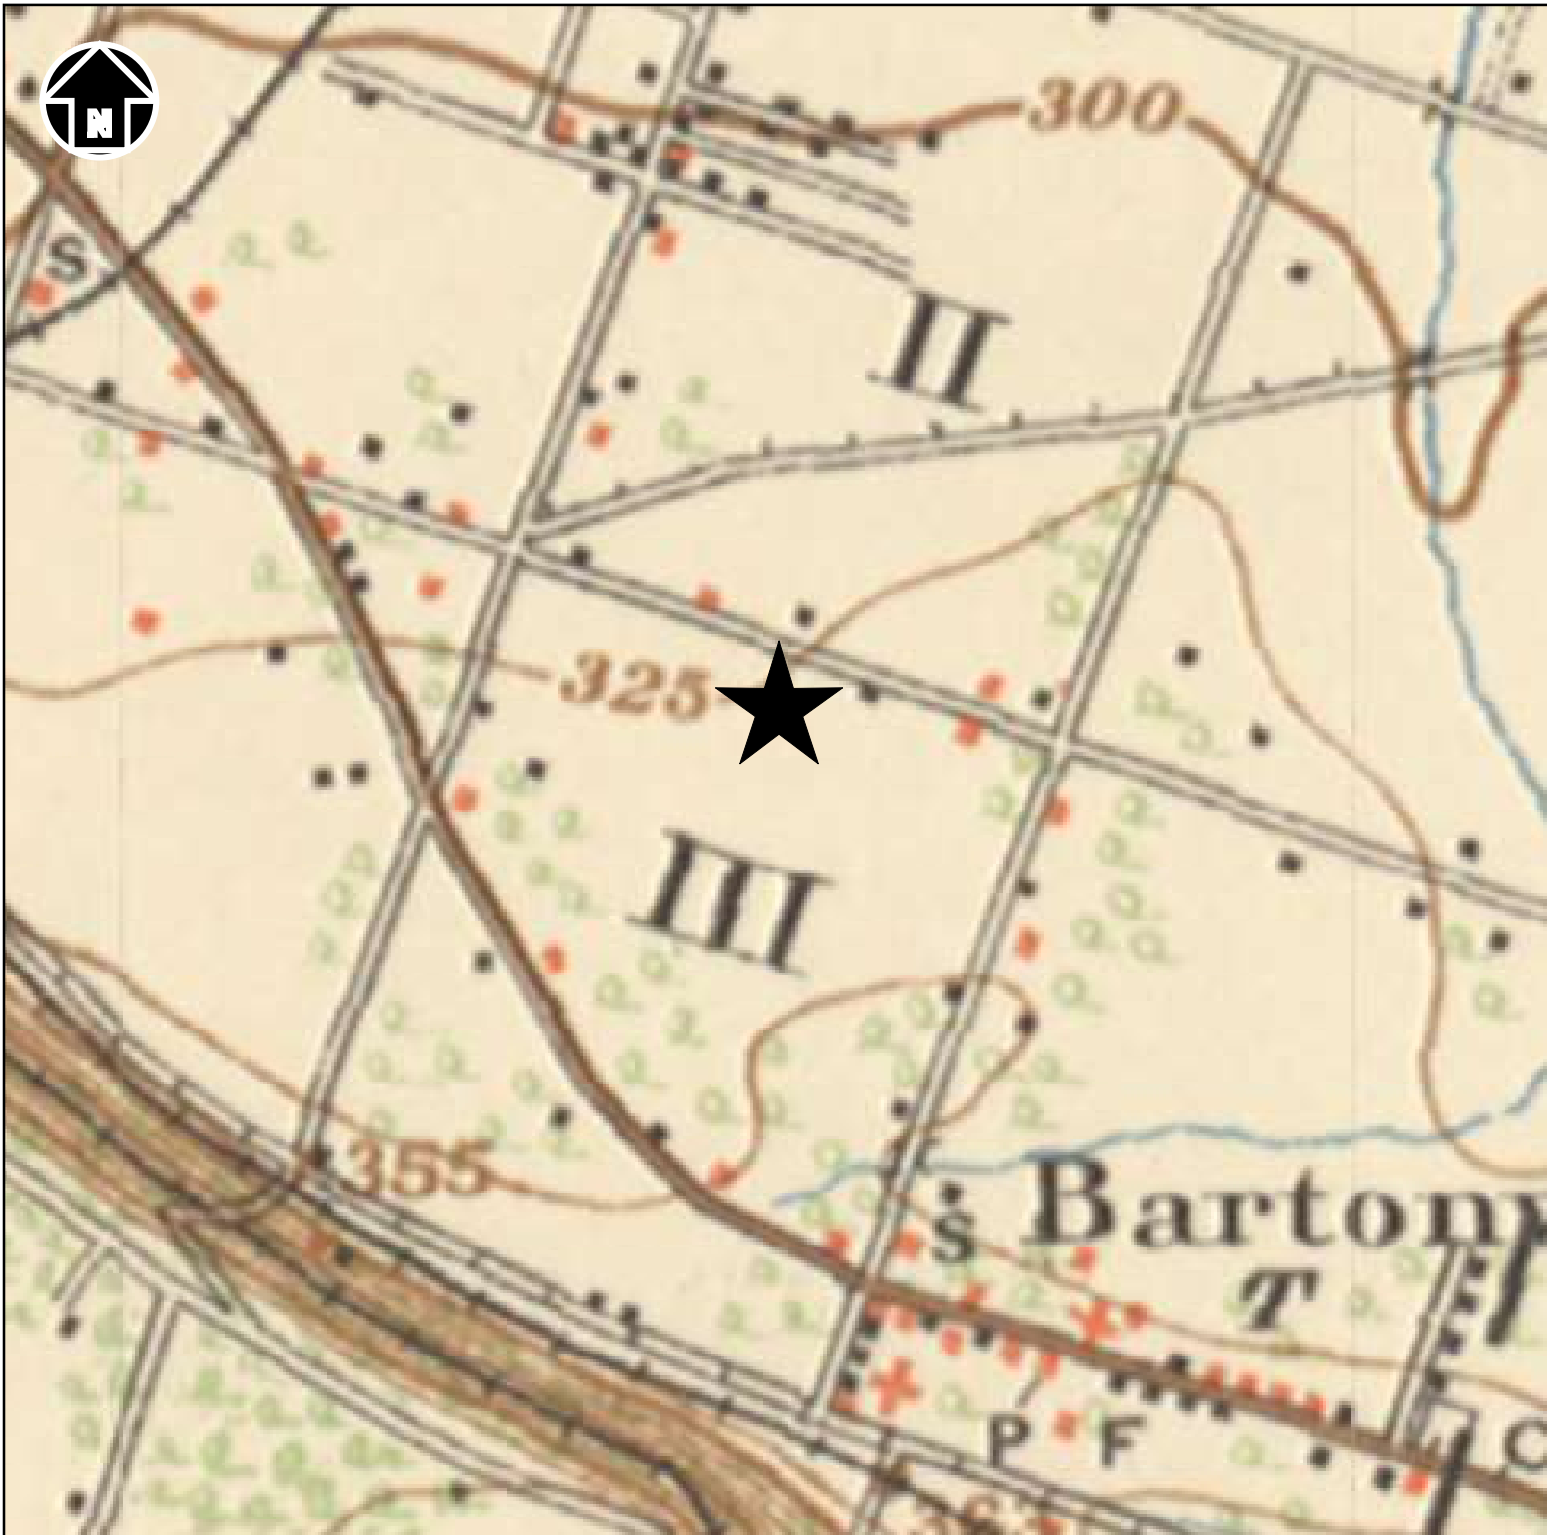
DRAWING No. 4A

The review of the topographic maps did not reveal any PCAs that are likely to cause an APEC on the Site.
